**SNOWDONIA SLATE TRAIL**  
**SURVEY REPORT & RECOMMENDATIONS**  
**2024**

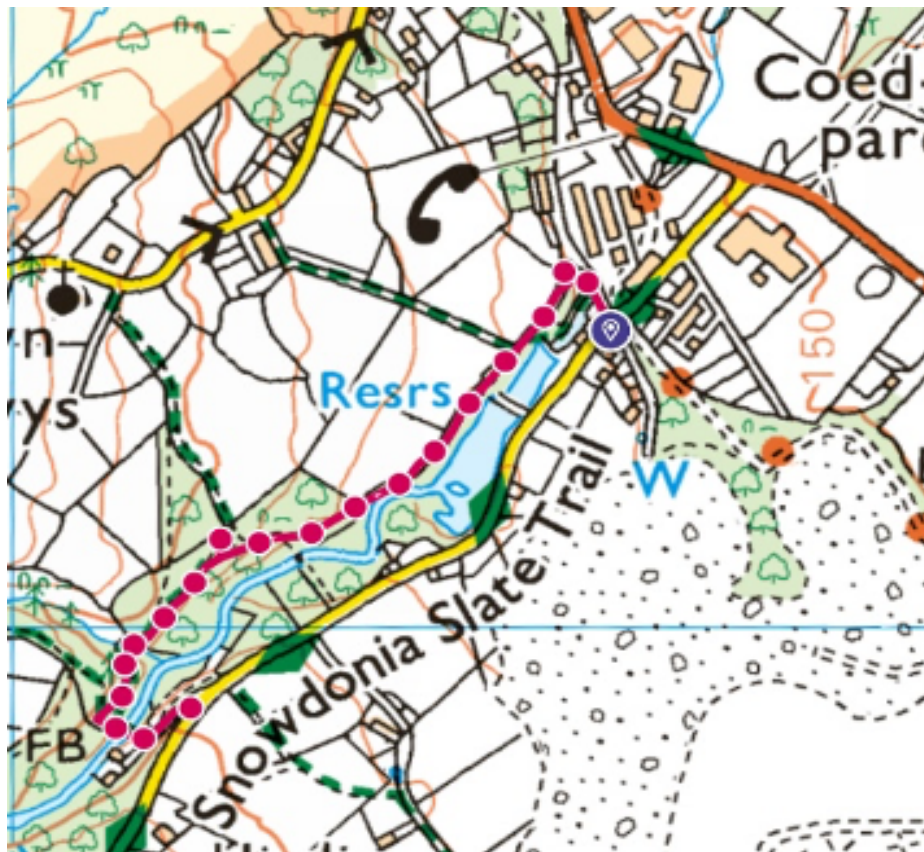
### (i) Yr Ocar alternative, south of Bethesda

This alternative route just south of Bethesda at the start of a long up hill road section is much more pleasant, running alongside the river with slate fencing. It is also subject to a Definitive Map Modification Order application based on evidence of historic use. Whether this application is successful is to be awaited, but nonetheless it is a much more attractive route than the road section which is the start of a longish uphill stretch. Photos of this section of the route can be viewed at **Appendix 8a**. Details of improvement works required are outline in **Appendix 9**.

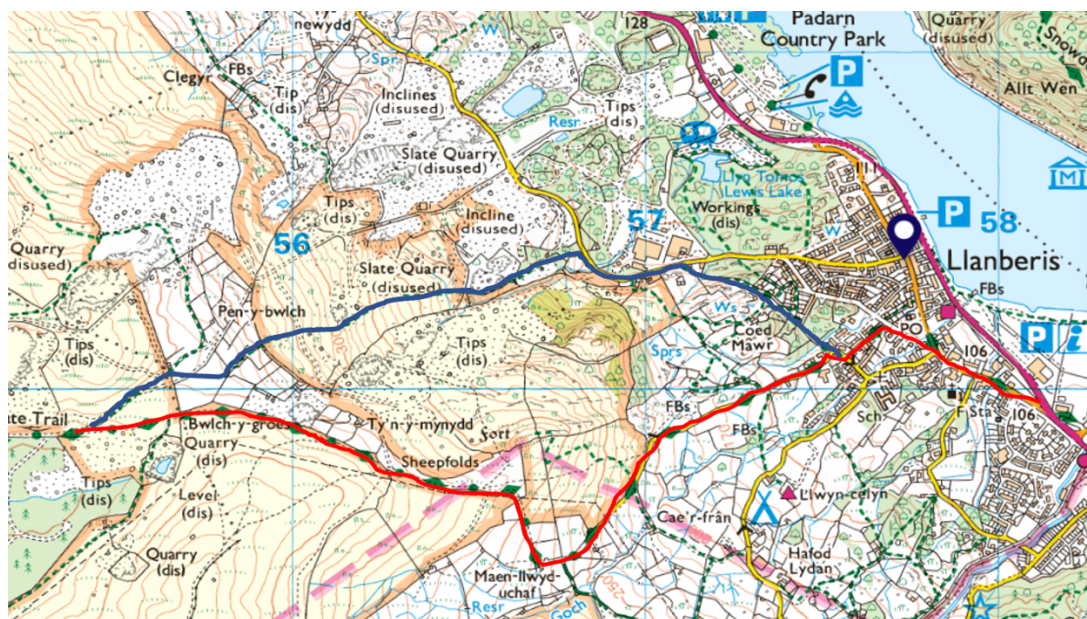
## (ii) Llanberis alternative

A suggested alternative route to the existing Trail section heading west out of Llanberis running north of the existing route has been examined and is marked in a solid blue line on the map below. The current route is marked in a solid red line to the south of the blue line. The alternative runs along an existing public footpath.

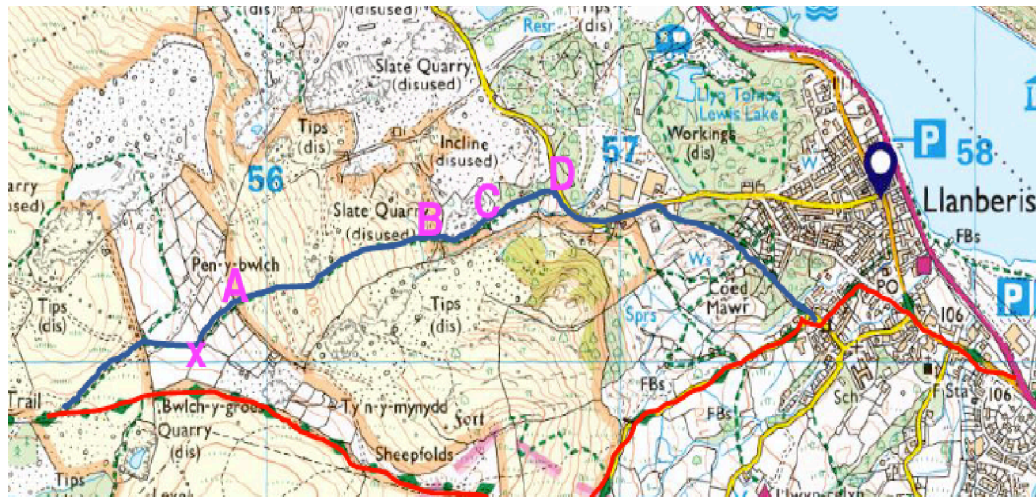
This alternative has quite a few issues that would need to be resolved to make it a suitable alternative. With reference to the map below with points marked on it the following issues have been noted.

Just southwest of Point A the route is blocked by a stone wall and fence marked at Point X but on the ground, it appears walkers have carried on south to a gate that joins the Trail albeit not a legal footpath. Point A at the time of survey had a gate made from a couple of hurdles, tied together, so that it couldn't be opened and had to be climbed/jumped over. However, on a second visit, these had been moved and opened but it clearly needs a more permanent structure. At Point B there is ladder a stile with a broken bottom rung. Between Points B-C there is a short, exposed section very close to a deep drop into to a disused quarry pit that would need protective fencing or a slight diversion away. About 200m section west of Point B is wet and tends to be wet/boggy all year round. Point C is the location of the fallen down fence. The path is on the opposite side to what's marked here too. Photos of the alternative and issues are at **Appendix 8b**.

Whilst this alternative section out of Llanberis clearly has quite a few issues that would need to be addressed to make it safe and bring it up to National Trail Standards, it does significantly reduce road walking. It would remove 1 mile of road walking and another 1 mile of hard-core surfaced track walking on a section of the existing Trail. It thereby significantly reduces hard surface walking and makes the route more interesting, taking in more sights of the local slate heritage including a former settlement.
