### **Appendix 3: Llanberis to Beddgelert**

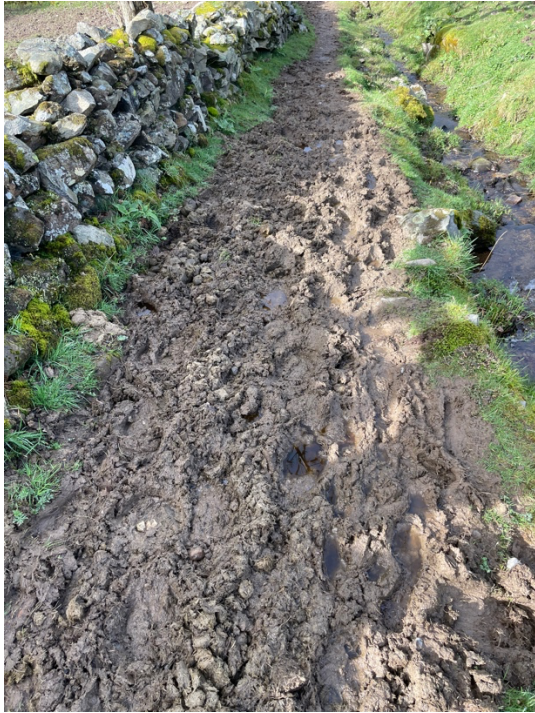
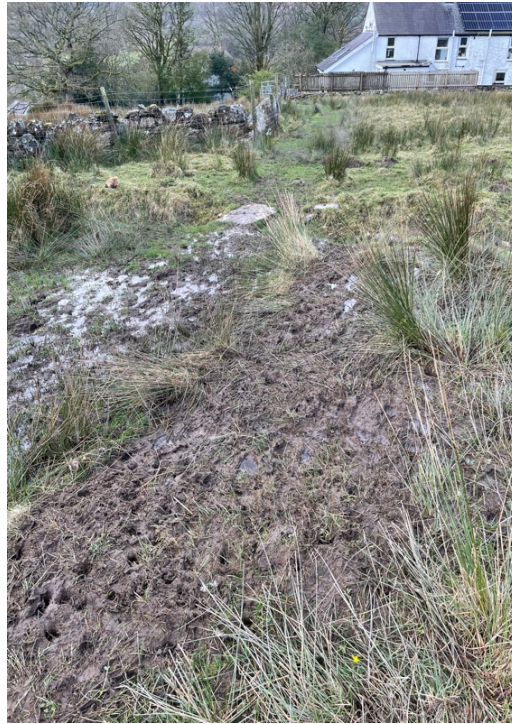
Photos 43 & 49 – approx. 200m wet section and poached by livestock section just before Waunfawr. Grid Ref: SH 53143 59387

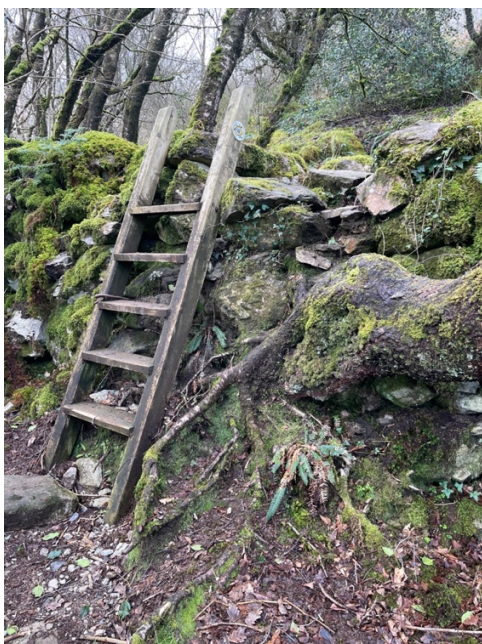
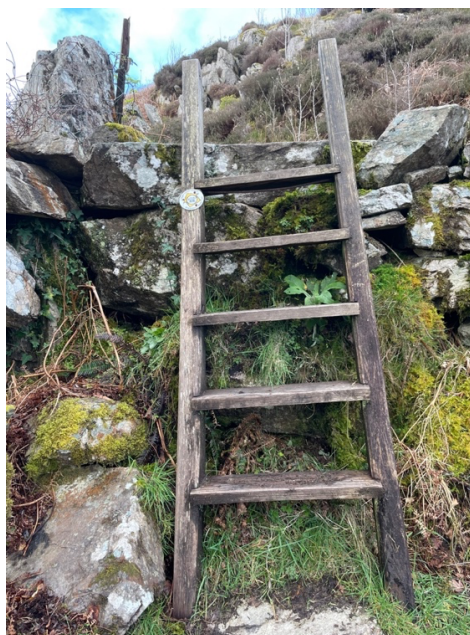
Photos 62 & 63 – Ladder stiles requiring anti-slip in woodland after Waunfawr. Around SH 52222 58511

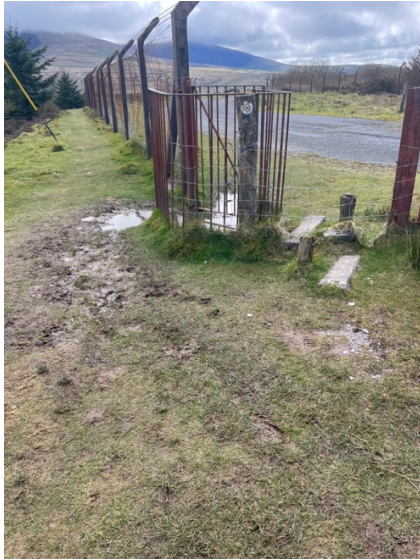
Photo 101 Above Dorothea quarry before reaching Nantlle need for clearer waymarker so people don't go through kissing gate but instead keep to left of fencing.  
At Grid Ref: SH 50371 54287. (nb, resolved already)

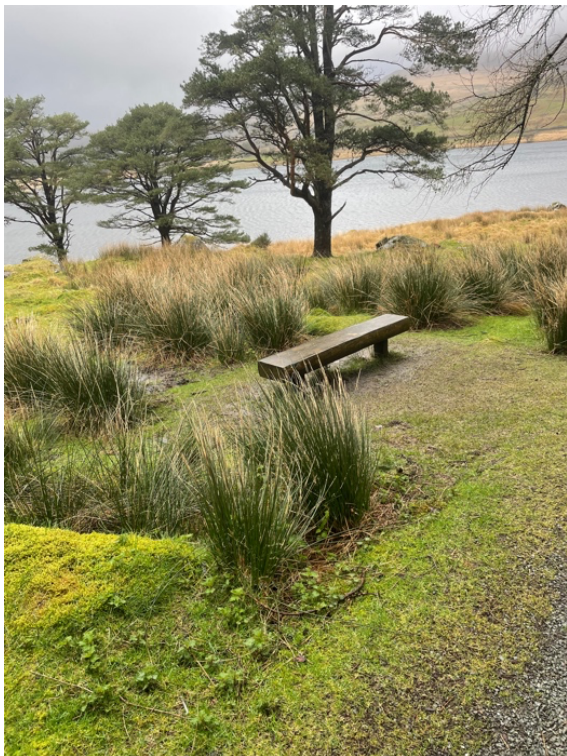
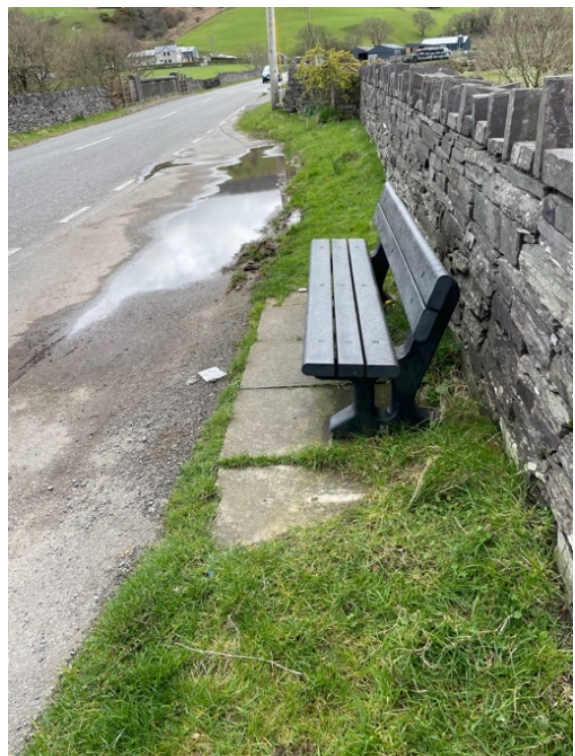
Photo 153 Bench examples - (bench on Rhyd Ddu to Beddgelert section, Grid Ref: SH 56603,52202) and 116 (bench in Nantlle, Grid Ref: SH 50932,53028).

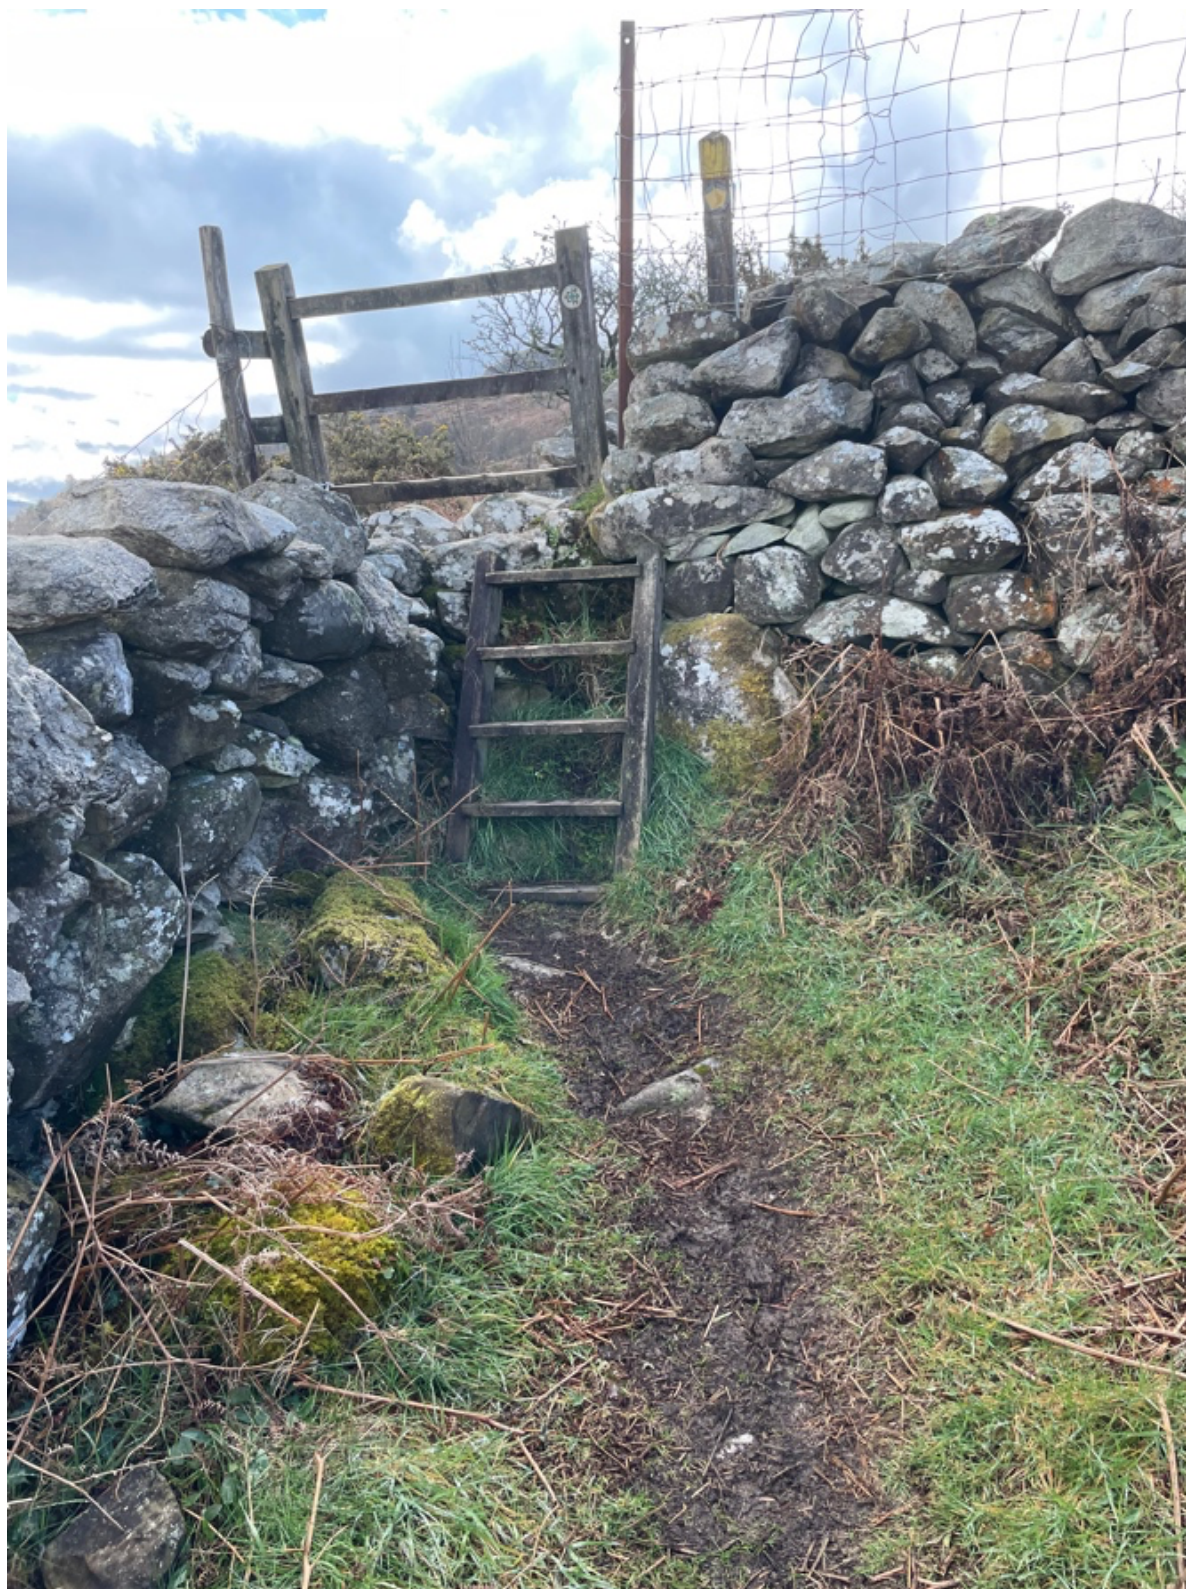
Photo 65 – precarious ladder stile /railing northern edge of woodland out of Waunfawr which is exposed and tricky to use especially as at height in stone wall corner with drops either side - could do with safer structure over. SH52076 58385.

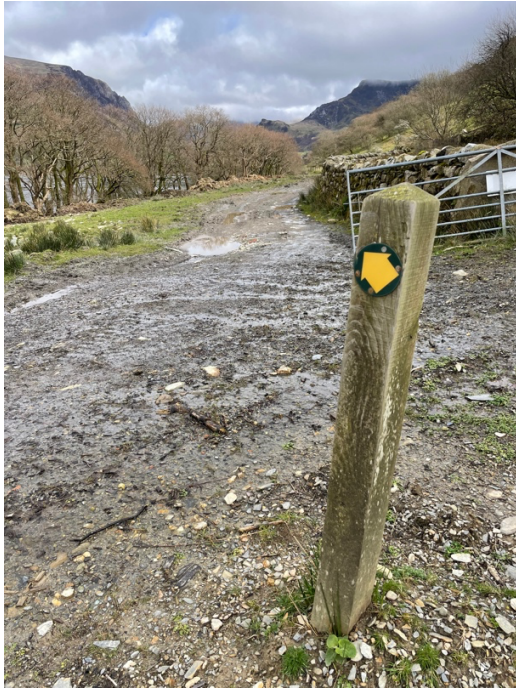
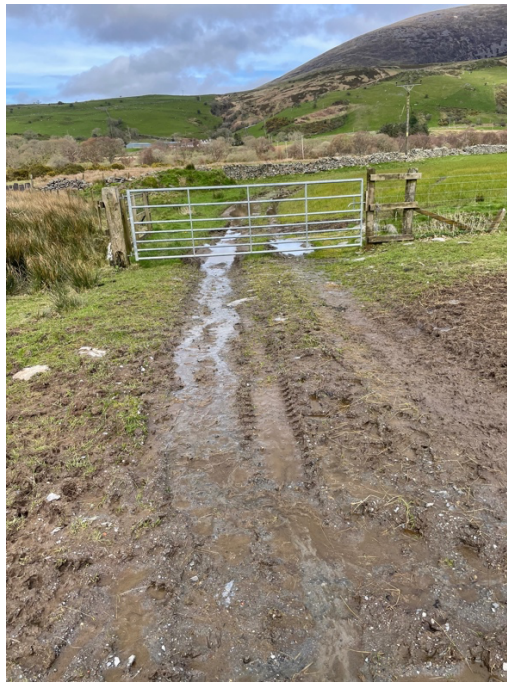
Photos 124 & 127 – long approx. 800m wet section east of Nantlle. Around centre point  
Grid Ref: SH 51814,52804.

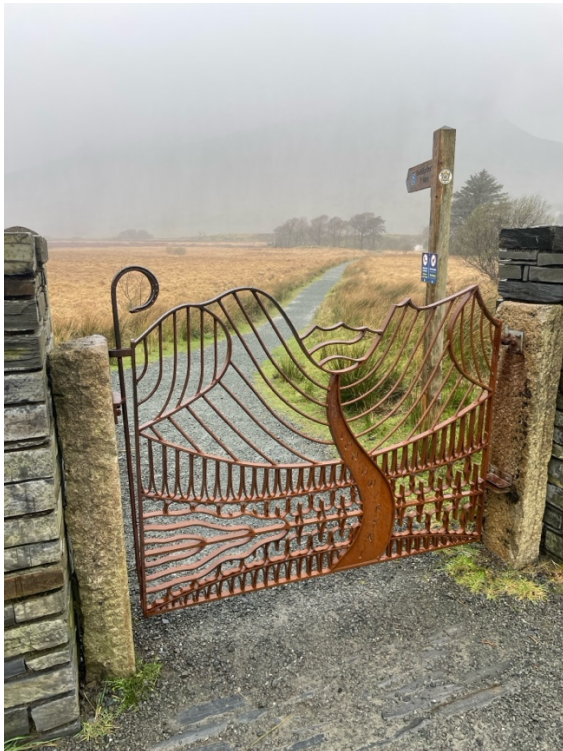
Photo 144 – Heritage style metal gate on route as Trail leaves Rhyd Ddu, Grid Ref: SH  
57061,52579
