## **Appendix 8: Alternative route sections at Yr Ocar, nr Bethesda & Llanberis**

**8b - Llanberis alternative viewed from west to east with points of interest /issues along existing public footpath.**

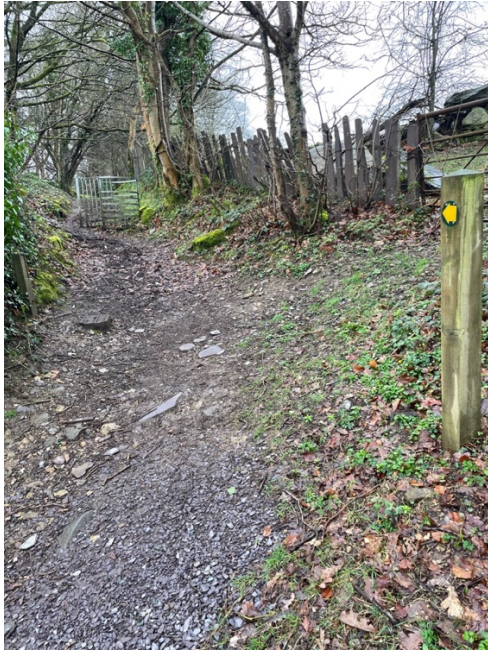
**8a (i) - Yr Ocar alternative** - More pleasant northern end of alternative south of Bethesda at Yr Ocar. Route runs alongside stream and slate fencing and in woodland and already signed as permissive route. **Grid Ref: SH 61444,66263**

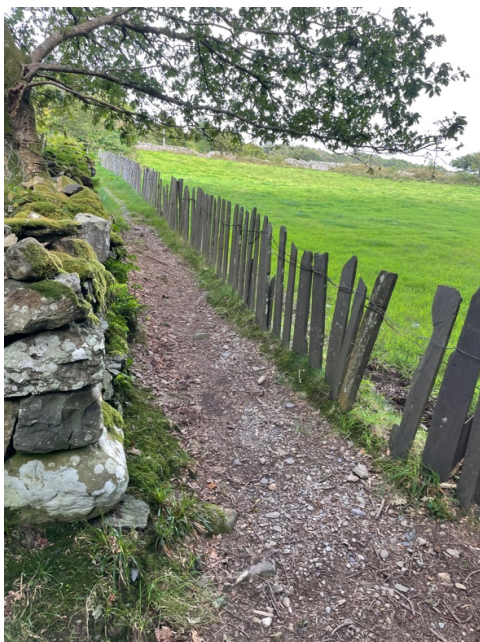
**8a (ii)** - most of route has good wide surface before enters wood with lovely slate fencing bounding route. Becomes narrower though at southern end in woodland. Grid Ref: **SH 61442 66271**

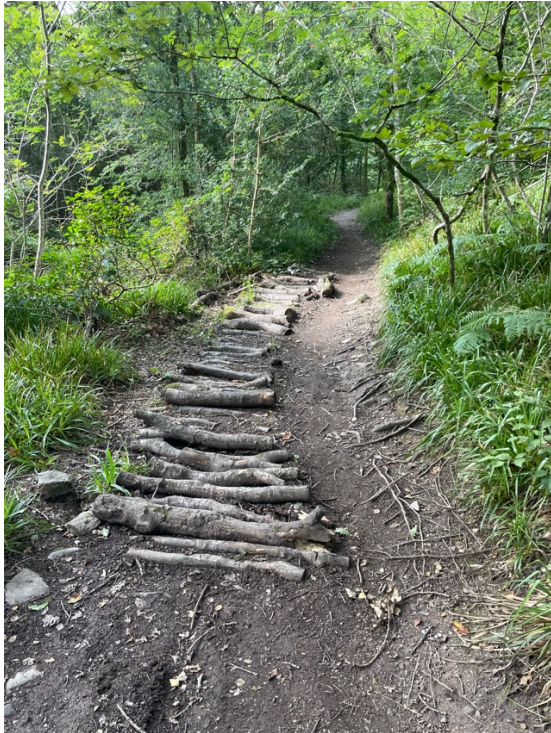
8a (iii) rough poor surface laid with logs for about 8m needs removing and proper gravel surface laying. Grid Ref: **SH 61267 66101**

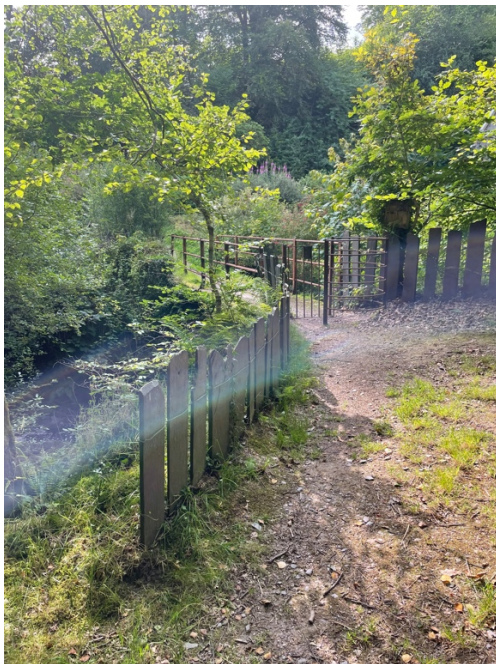
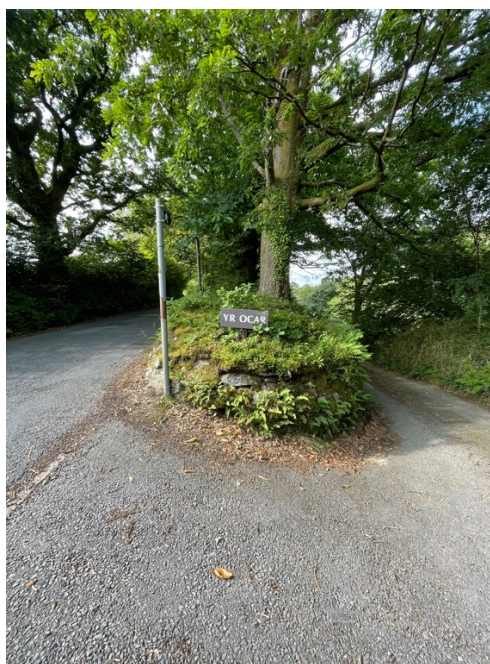
8a(iv) – route at southern end crosses good footbridge where it is now already part of an existing public footpath and joins public road at top of drive of property of Yr Ocar. Grid Ref: **SH 61101 65909 & SH 61151 65935**

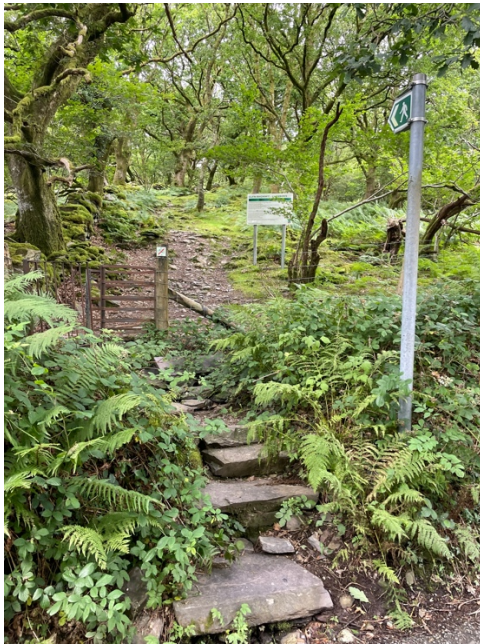
Start of route off public road at eastern end Grid Ref: **SH 56815 60418**

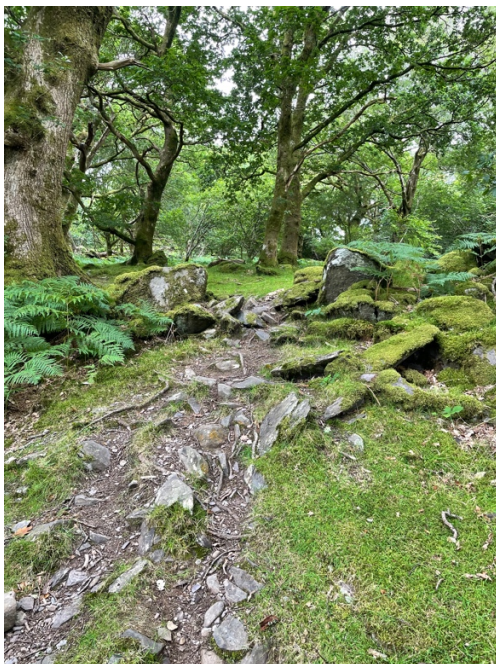
Route climbs up woodland via gaps in stone walls, Grid Ref: **SH 56776 60408**

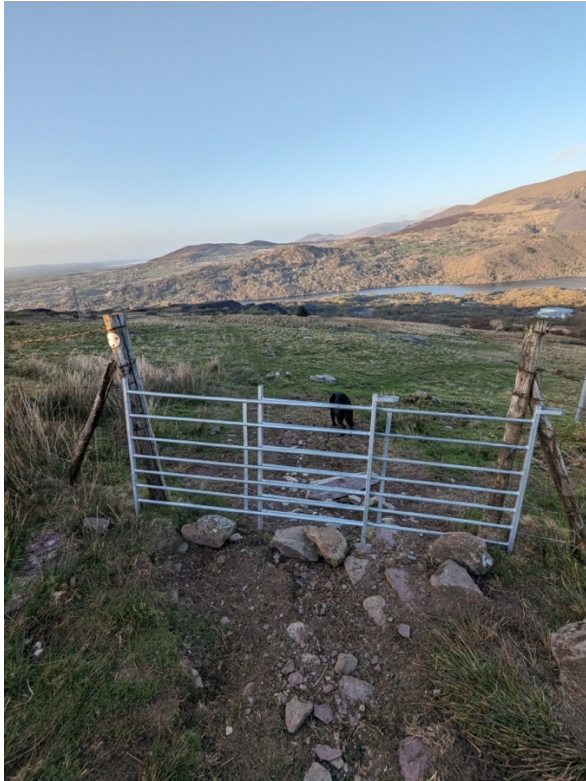
Point A – gate made from hurdles (Grid Ref: SH 55908,60140), however hand been tied back and was open on second visit, better structure required ie field gate or gate within gate.

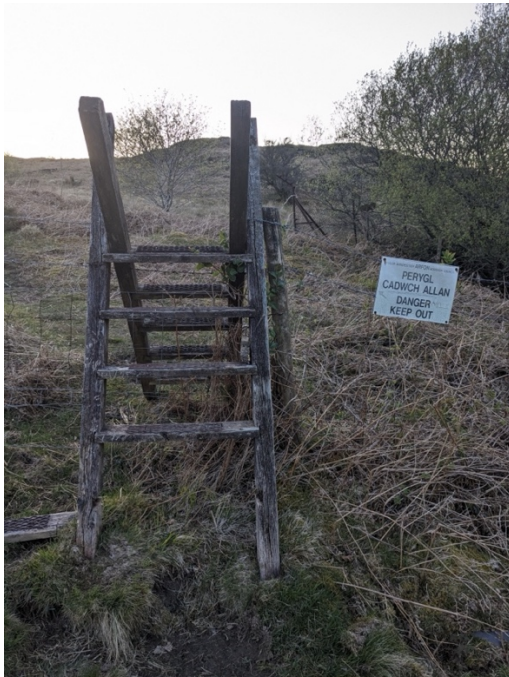
Point B – stile with lower broken ladder rung (Grid Ref: SH 56478,60305)

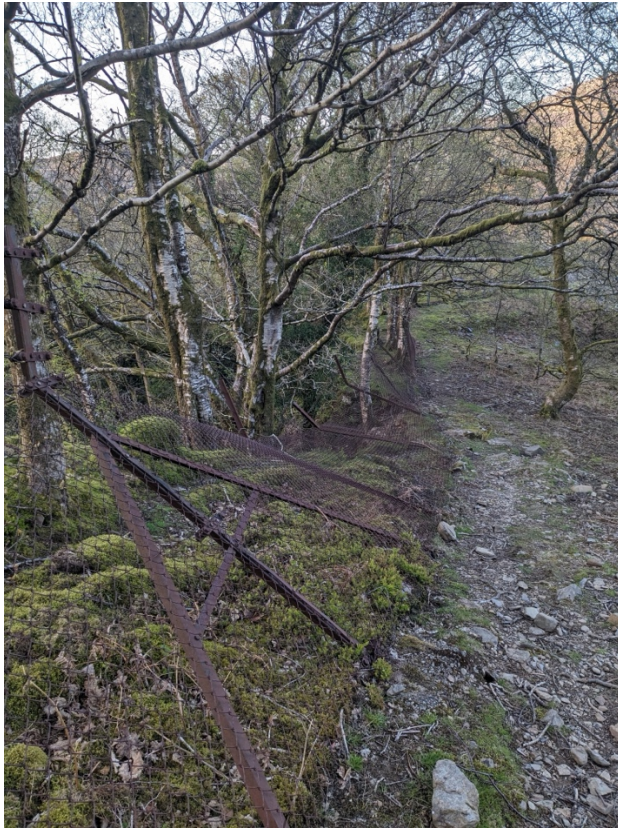
Point C – fallen down fencing next to path (Grid Ref: SH 56609,60328)

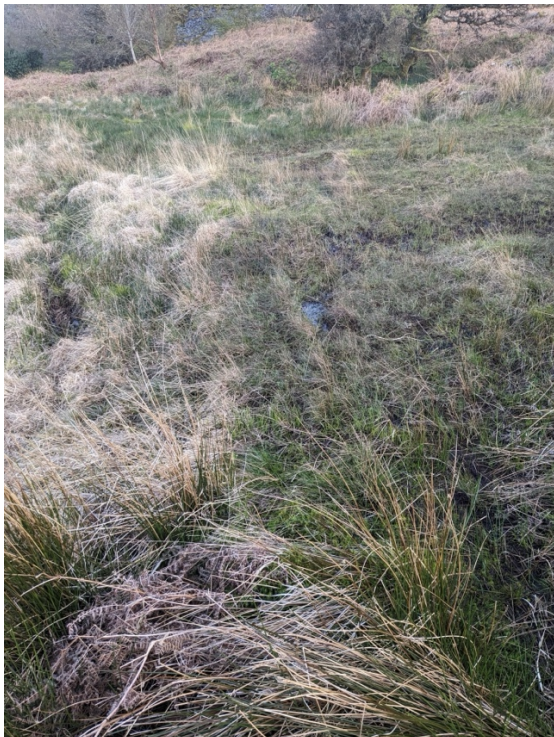
Wet /boggy area in middle of Llanberis alternative. Approx 200 m west of Point B

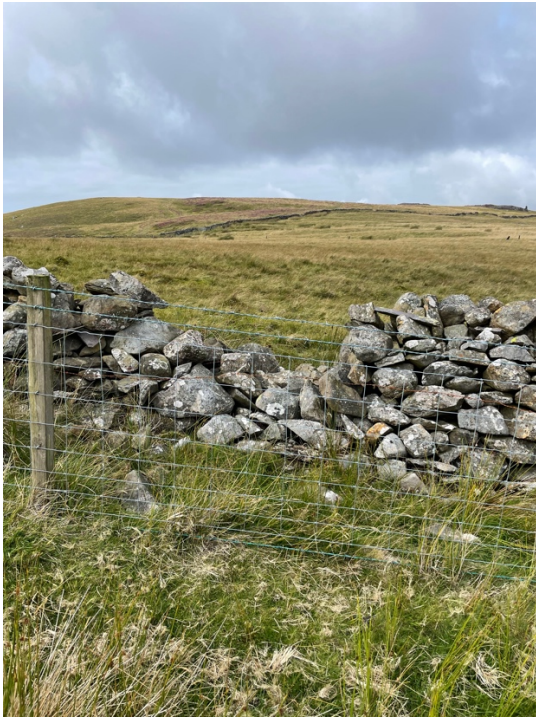
**Point x** – legal line of public footpath route blocked by stone wall and fencing at SH 55813 60037 near western end of route (note appears on ground people continue to head south to join Trail as gate where rejoins Slate Trail but not legal route).
